**2004 Operations, Maintenance,
and Monitoring Report**

Cameron Prairie Refuge Protection

State Project Number ME-09
Priority Project List 1

May 2007
Cameron Parish

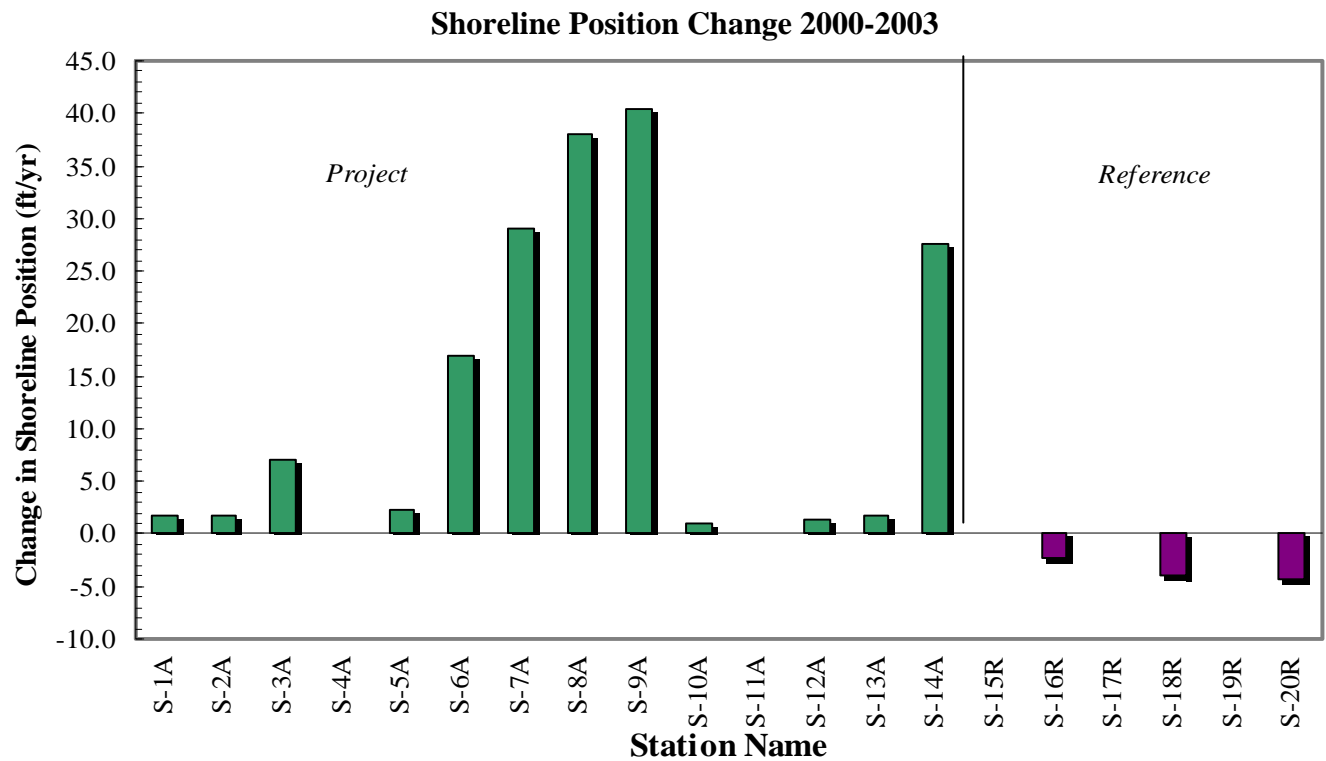
Shoreline change data were collected in 1995, 1997, 2000 and 2003. Presented here is the comparison between the 2000 and 2003 surveys (figures 4-8, table 1). Mean shoreline change rate was calculated to be 13 +/- 15.4 ft/yr (4 +/- 4.7 m/yr) and -2.1 +/- 2.1 ft/yr (-0.6 +/- 0.6 m/yr) for the project and reference areas, respectively. The data indicate that the project has continued to be effective in preventing erosion at all project area stations. Shoreline position at the reference sites continued to retreat.

Figure 5. Shoreline position change within the Cameron Prairie (ME-09) project and reference areas for 2000-2003 in feet/year.

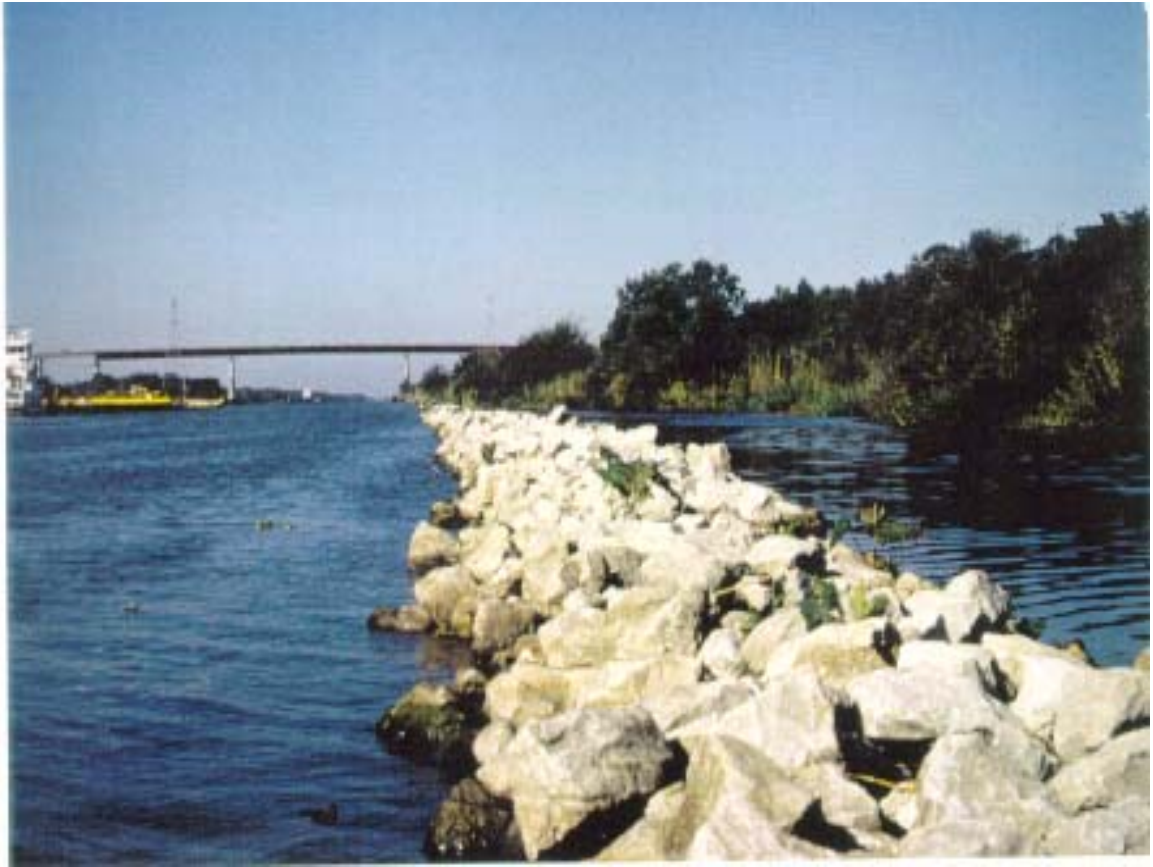
Figure 6. Photograph of the Cameron Prairie Refuge Protection (ME-09) project following construction in August 1994, illustrating the shoreline of the GIWW and the installed rock breakwater.

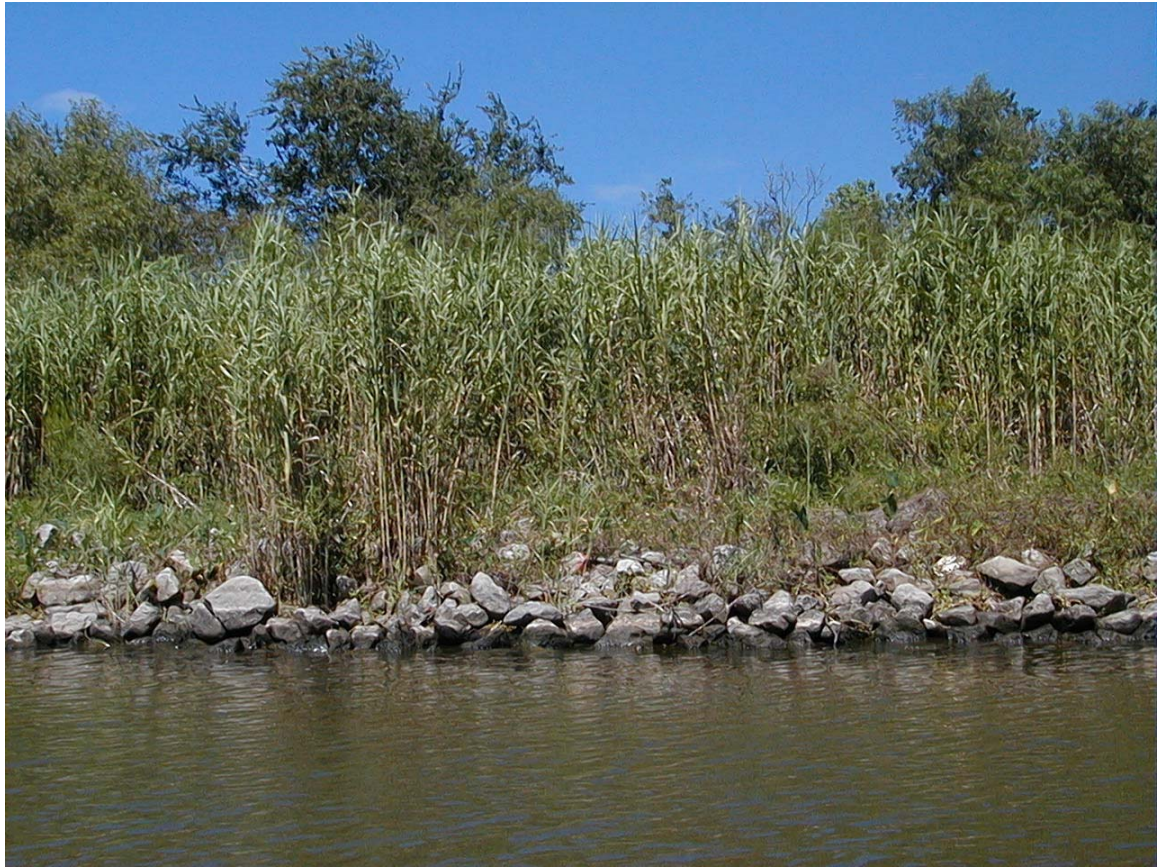
Figure 7. View of the Cameron Prairie rock dike taken August 4, 2003. Note the healthy condition of the *Phragmites australis* and other native vegetation colonizing the dike itself.

As a result of the accretion occurring behind the rock dike, natural freshwater vegetation has colonized behind and over the rock dike. The colonization of the vegetation created a navigation hazard for marine vessels traveling the GIWW at night and during low visibility situations. In 2001, the U.S. Army Corps of Engineers addressed the hazard by installing pilings with navigation warning signs. In the future, similar type projects implemented in freshwater areas should include navigation warning signs in the initial construction contract.

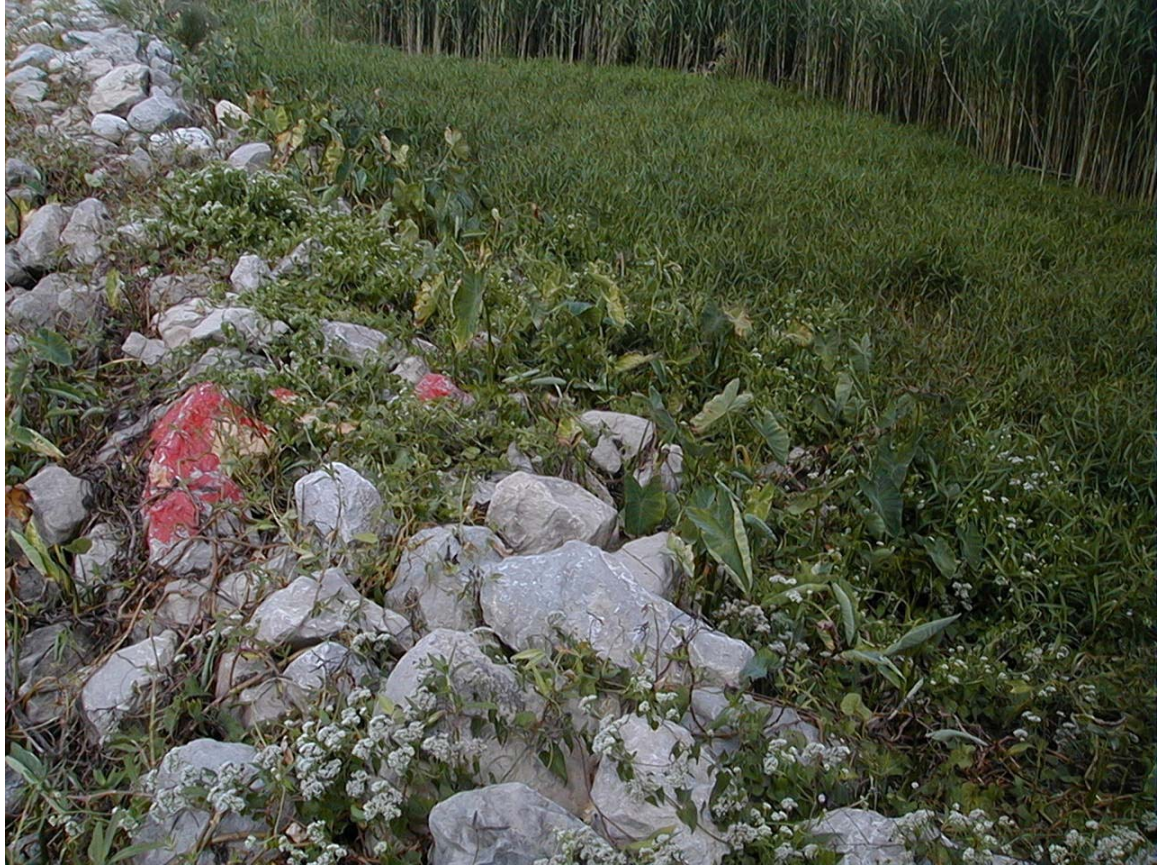
Figure 8. View of the Cameron Prairie rock dike showing naturalized vegetation colonizing the dike itself and the accreted marsh behind the dike. The red paint was used to mark the location of the shoreline marker for the DGPS survey.

The project has been effective at preventing shoreline erosion at all project area stations, while the shoreline in the reference area stations continued to retreat. Visual observation indicates vertical accretion of the wetland area at many locations between the foreshore rock dike and the shoreline.

A structural assessment survey performed by a licensed engineering/land surveying firm is recommended to evaluate settlement and stability of the rock structure along with any evidence of accretion on the land side of the structure.
